SURVEY REPORT of F/V VALBORG – KING MARINE SURVEYORS, LLC

SURVEY REPORT of F/V VALBORG

File # / survey date:..... FVKP112. / November 12, 2012.
Survey purpose:..... Condition and valuation for insurance risk evaluation.
Survey location:..... Great Cove Boat Club, 225 Main St. Eliot Maine 03903.
Requested by:..... Company president: Kirk Plender, P.O. box 579 Glen New Hampshire 03838.
Vessel owner:..... Dragor Fisheries Inc. P.O. Box 67 Peaks Island Maine 04108.
Vessel position:..... Out of the water stored upon jack stands and keel blocking.
Survey attendees:..... Kirk Plender and the surveyor (Geordie King).

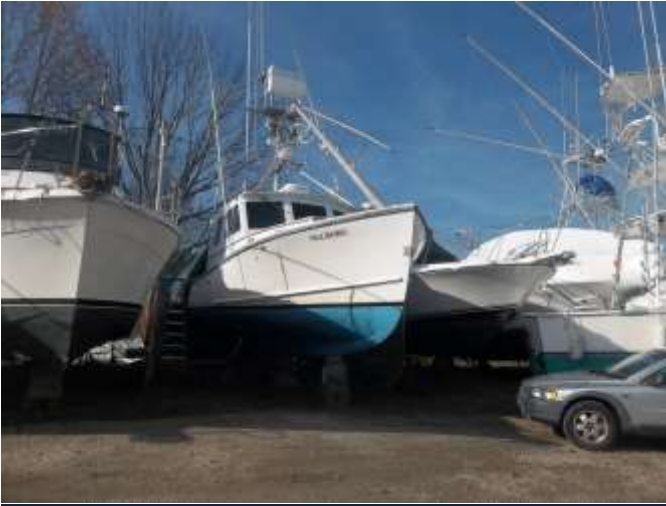
Stbd. bow view.

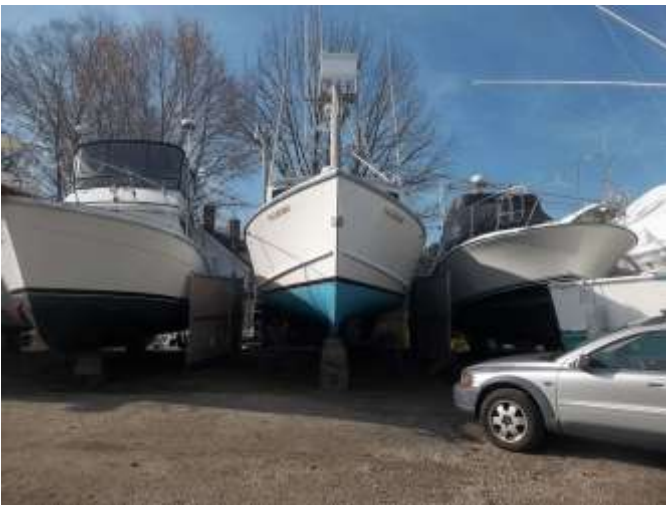
Bow view and tuna tower

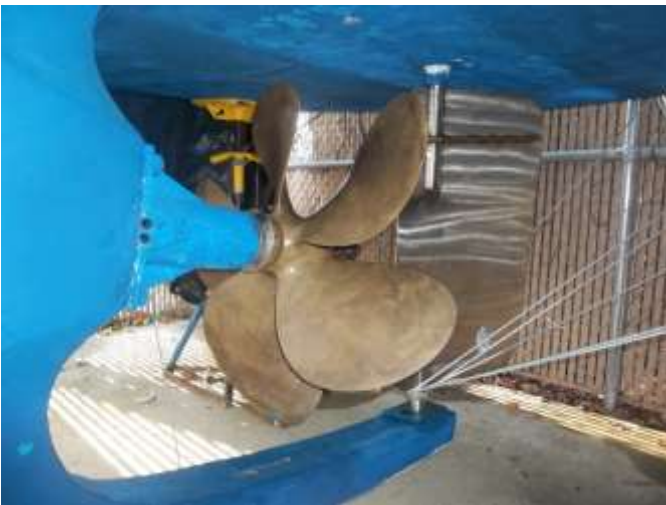
Underwater gear and skeg.

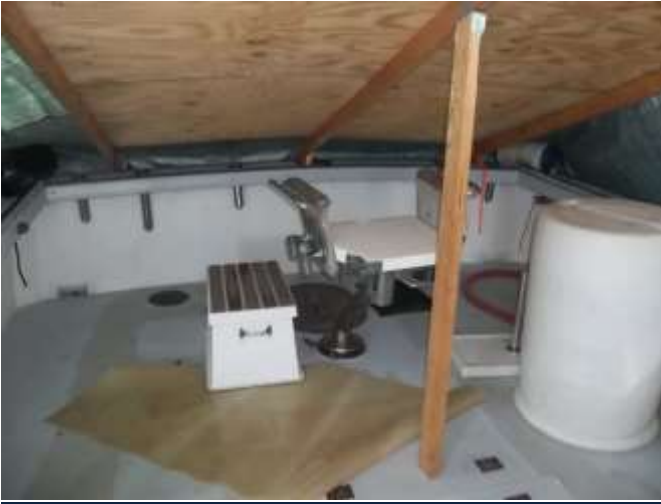
Cockpit view showing fighting chair

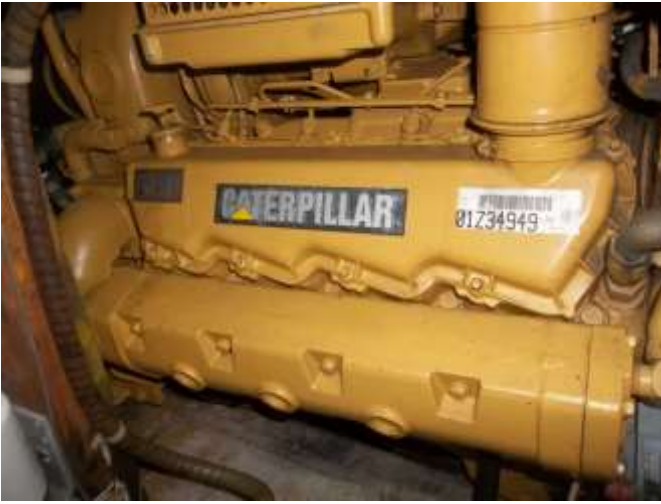
Engine view taken from stbd. side.

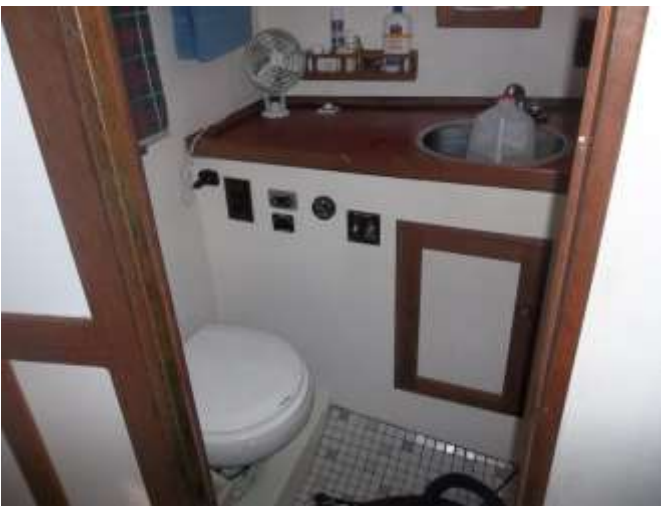
Head view taken from companionway.

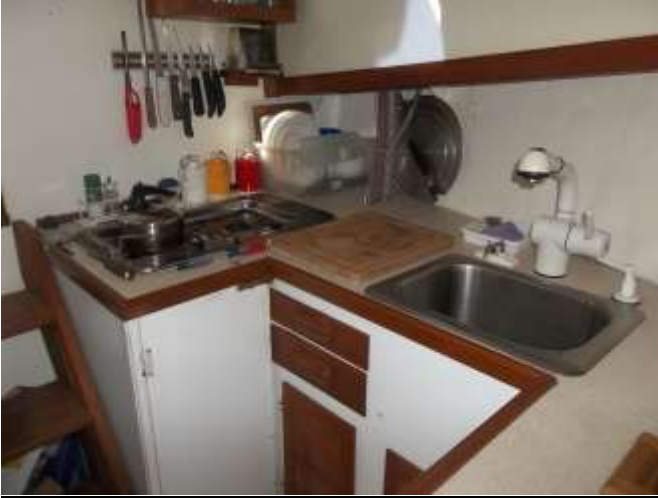
Galley view looking to pt.

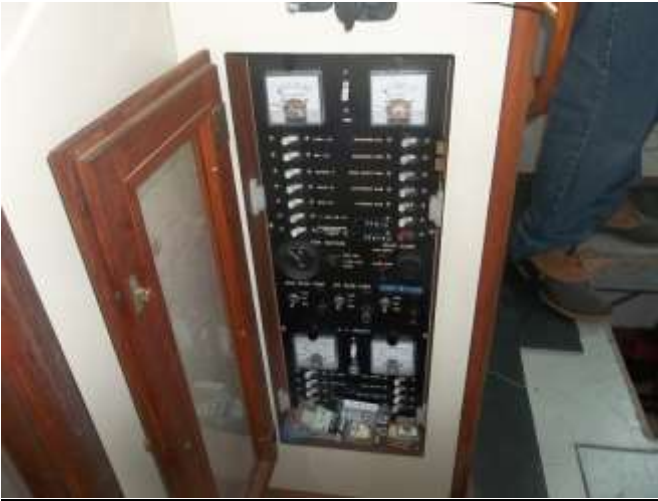
Electrical panel enclosure looking to stbd.

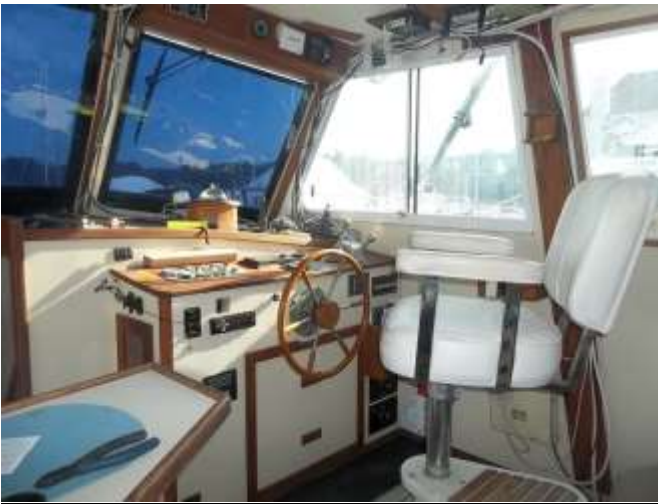
Helm station looking to stbd.
